20-251E

Re: **World Trade Center**
New York, New York

One World Trade Center

Subgrade (Parking & Storage Areas)

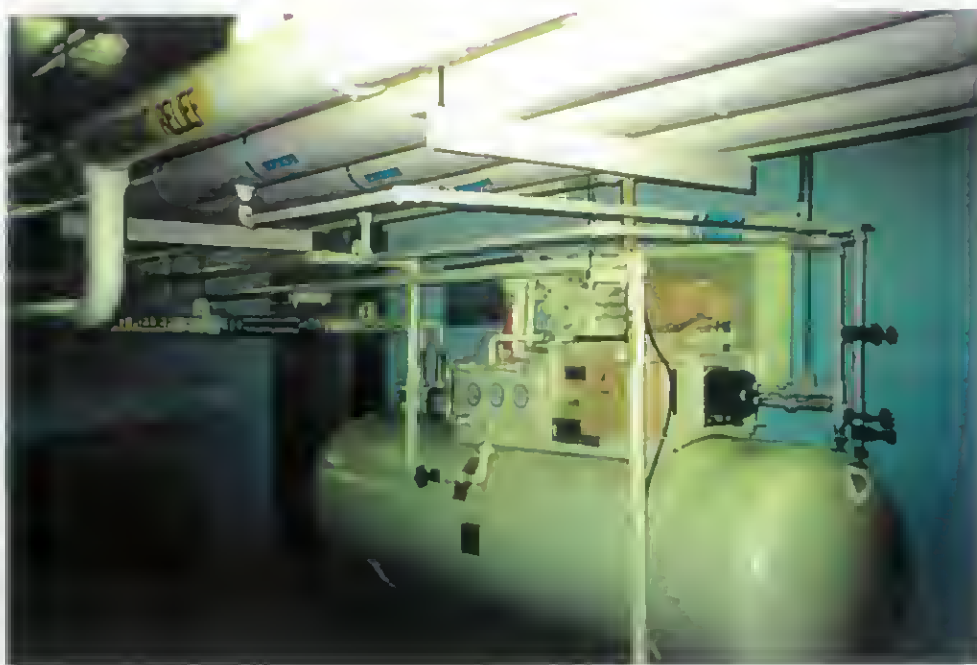
Photograph 9

Supplemental
chillers

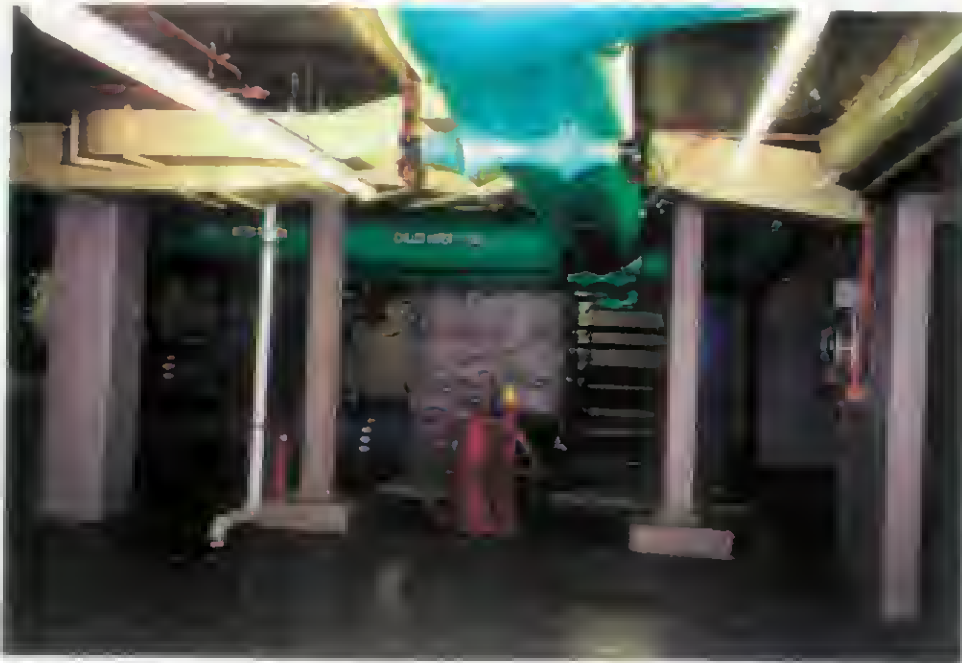
Photograph 10

Refrigerant
storage tanks

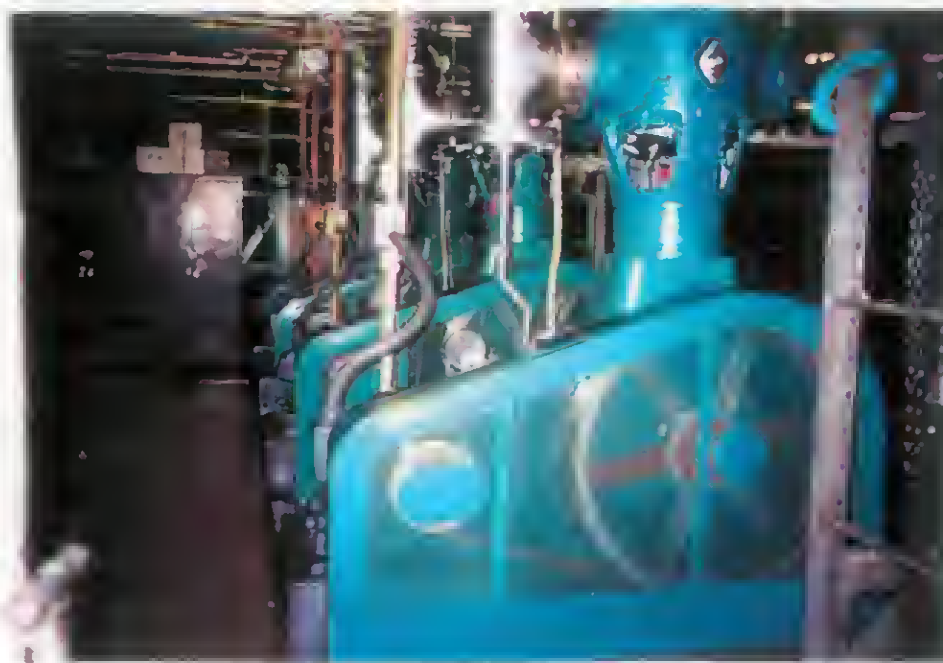
Photograph 11

Heat exchanger
for economizer
operation

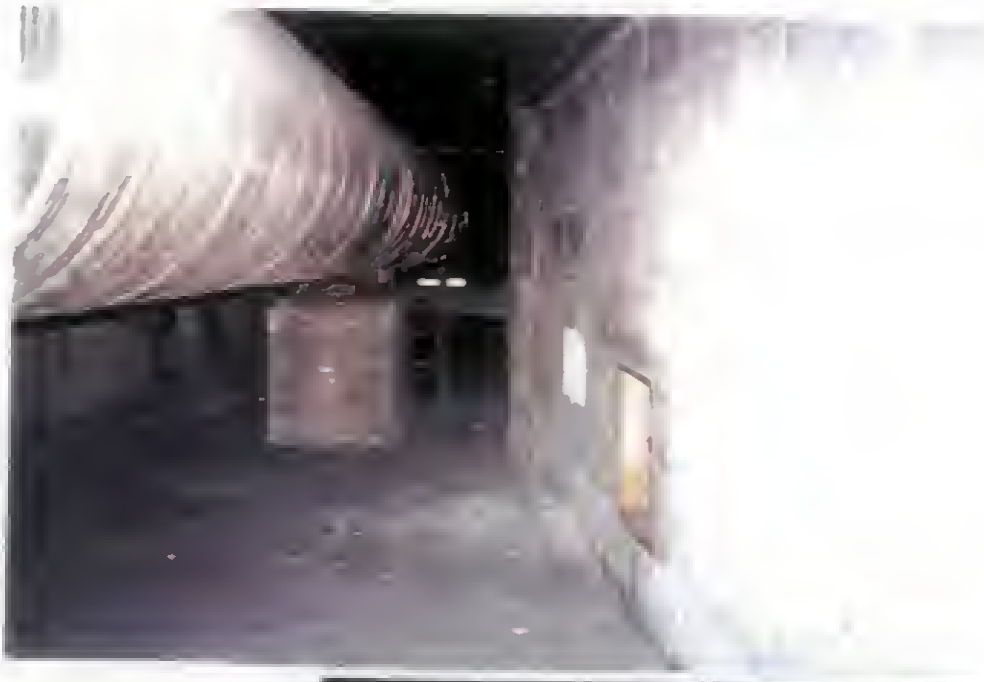
Photograph 12

Pneumatic
control air
compressors

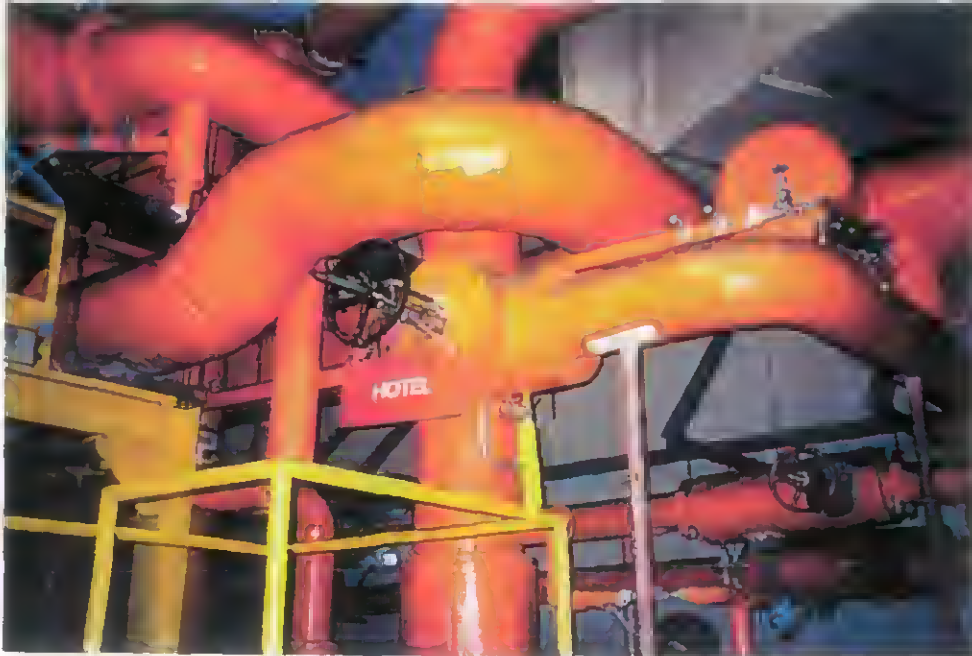
Photograph 14

Steam service
valve (planned
for replacement)

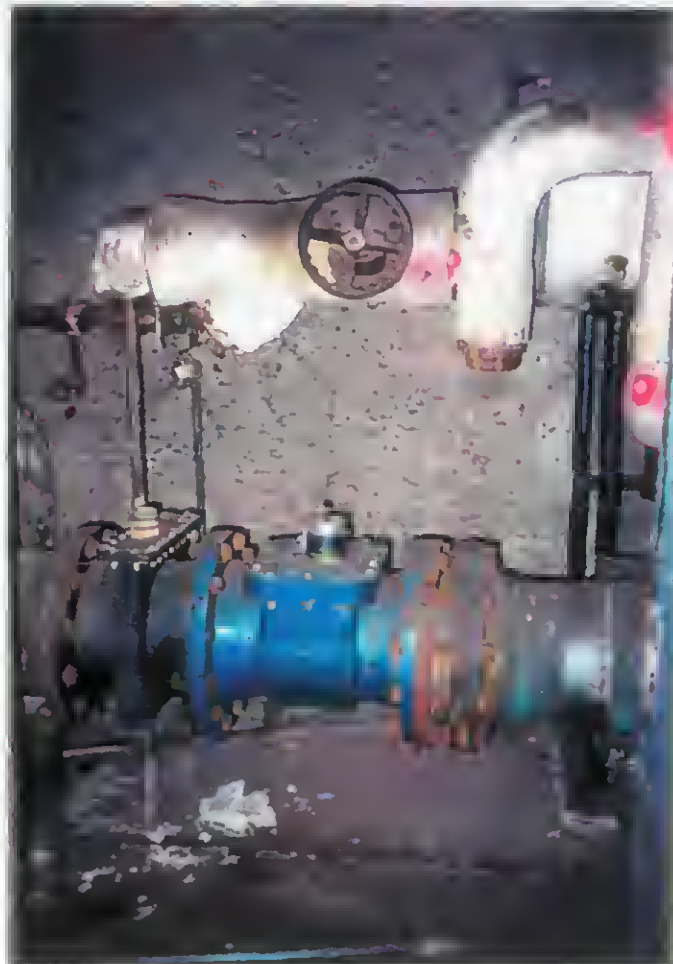
Photograph 15

Steam
distribution
plant

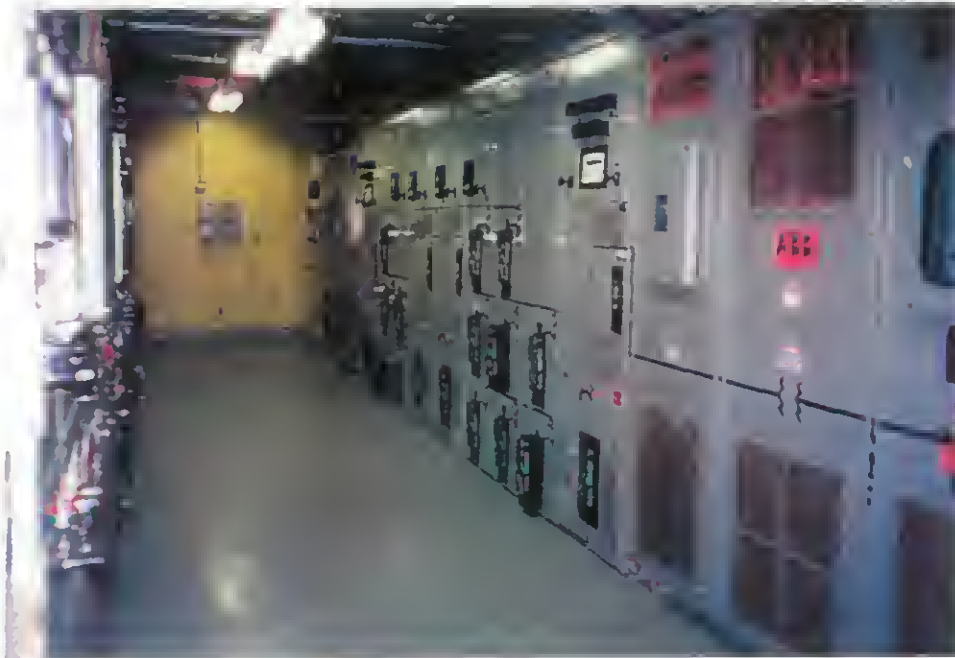
Photograph 18

Recently
upgraded high
voltage feeders

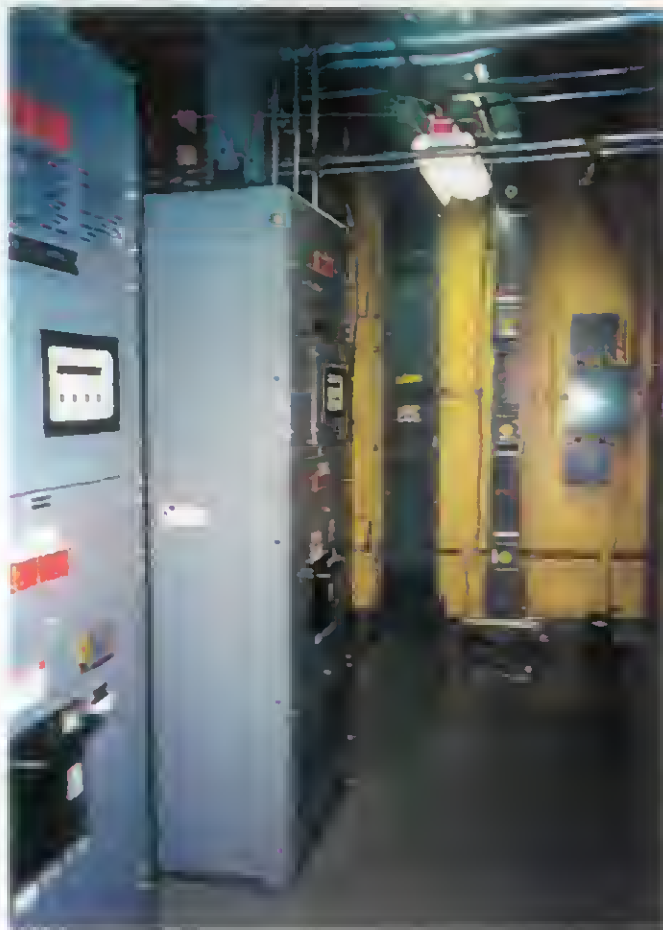
Photograph 19

Upgraded
electrical
substation

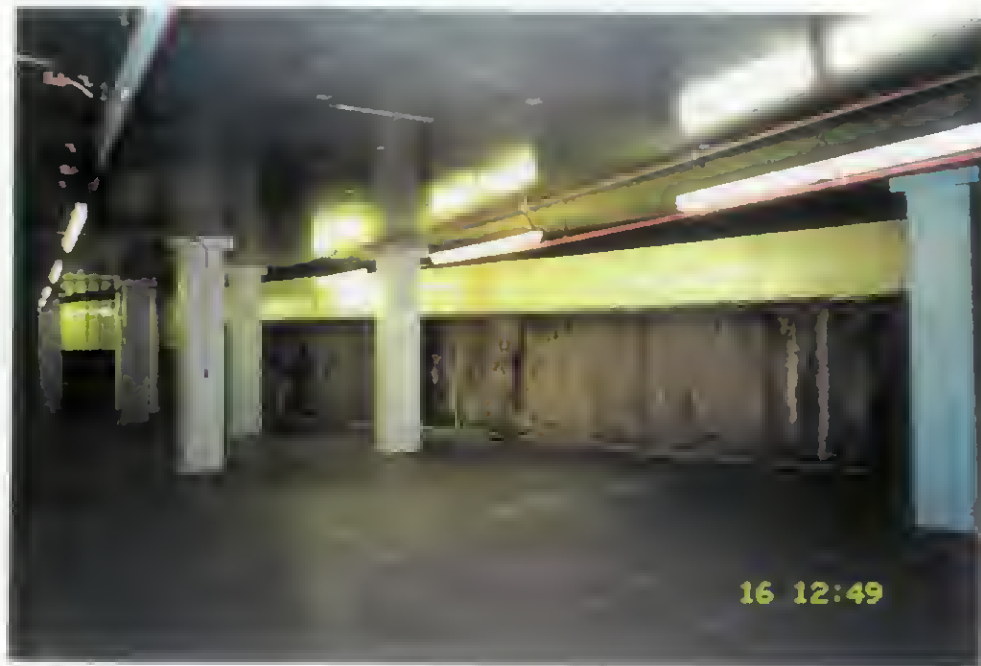
Photograph 1

Slurry wall exposed
in Level B5

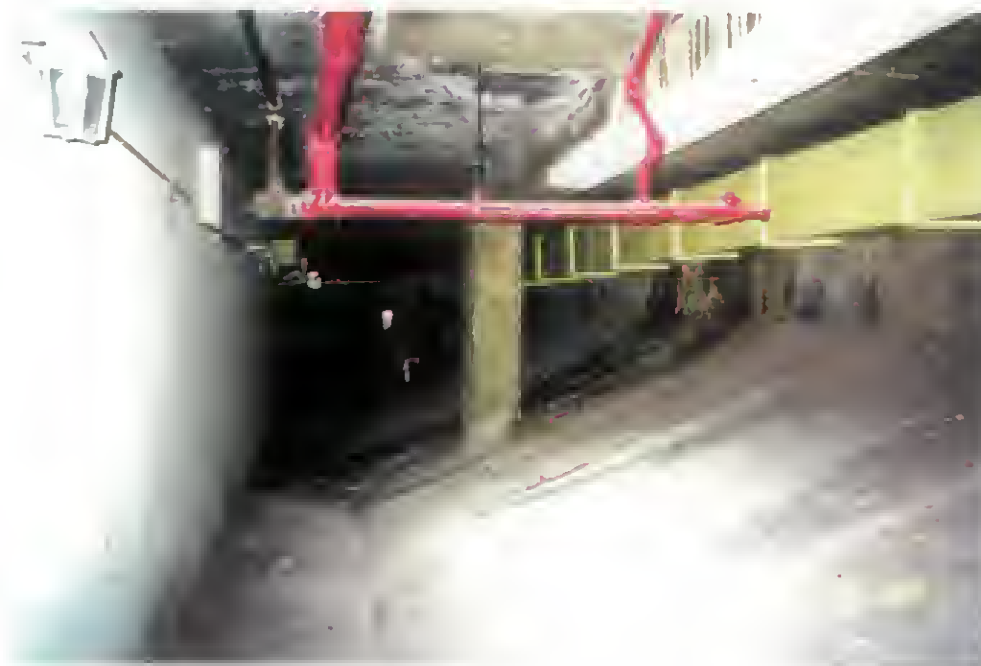
Photograph 2

Base of slurry wall -
Level B6

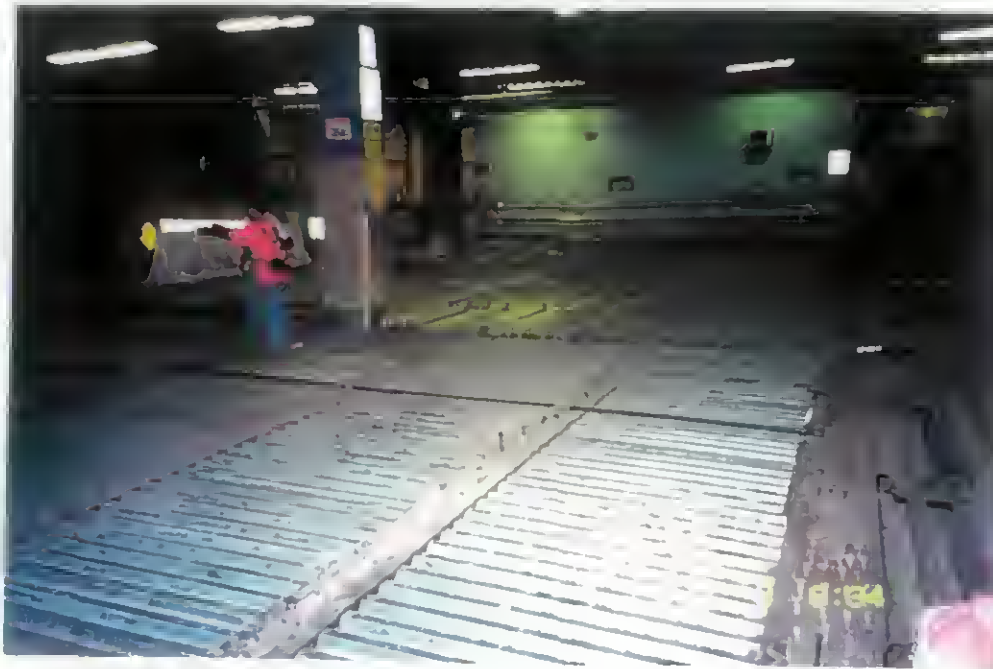
Photograph 9

New slab being
installed in loading
dock area - start of
multi-stage program

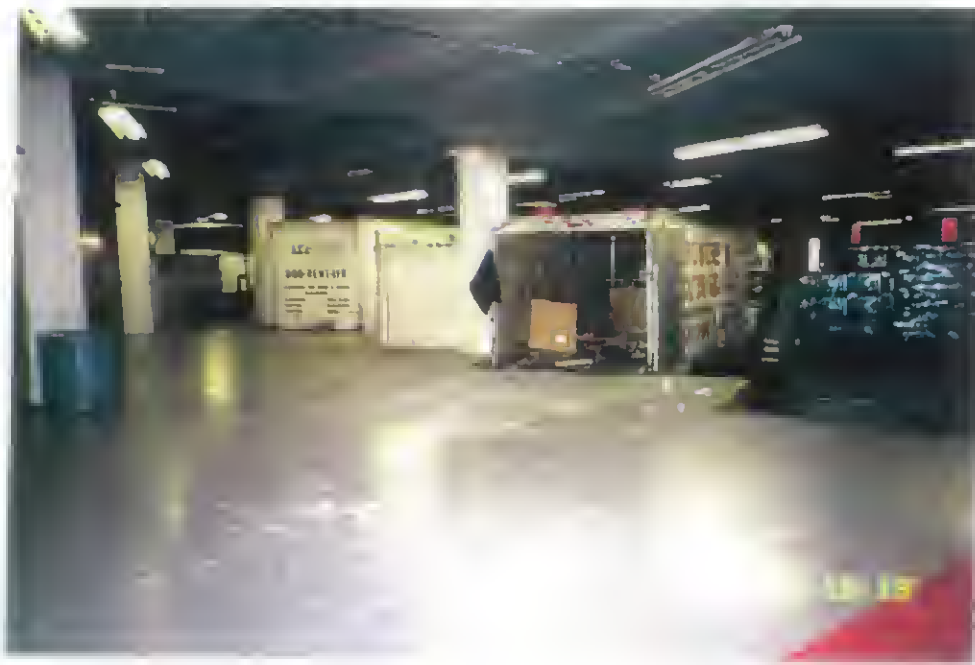
Photograph 10

Loading dock area

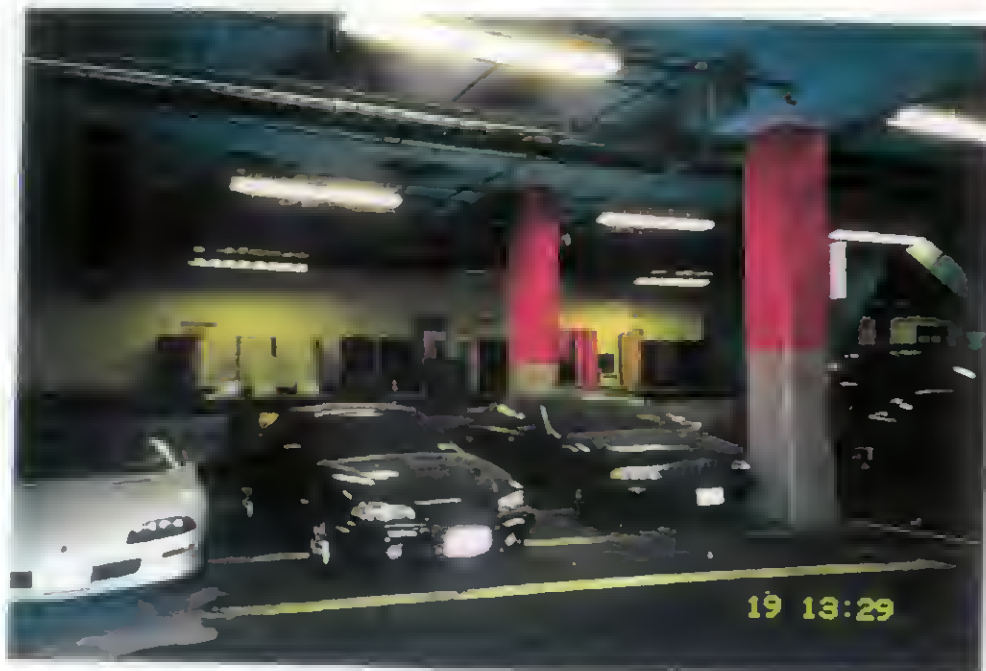
Photograph 11

Loading dock area
for US Customs
Buildings

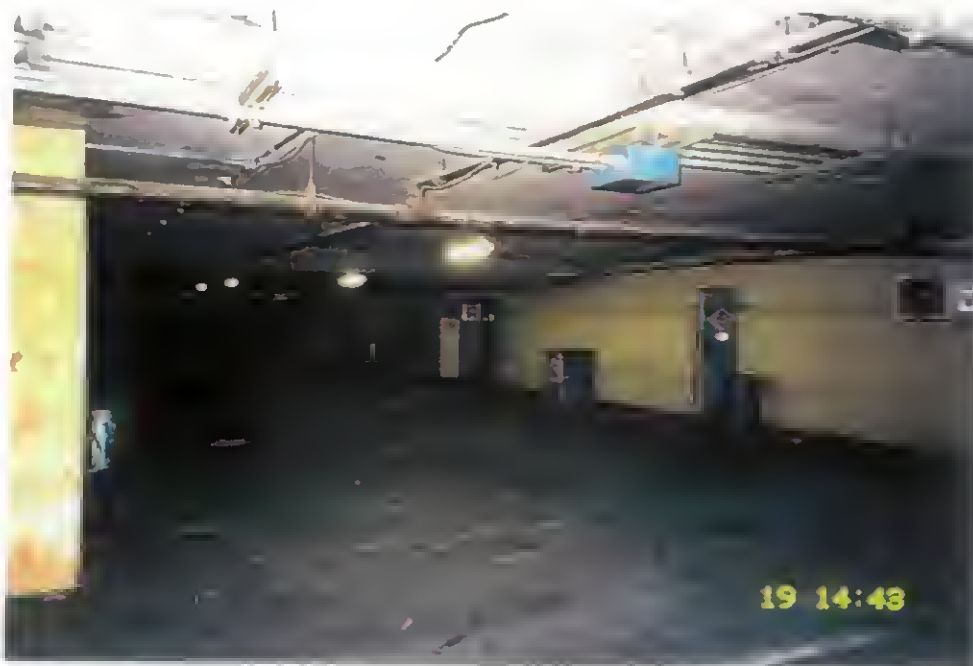
Photograph 15

Leased offices at
former parking area
(B1) for Marriott
Hotel

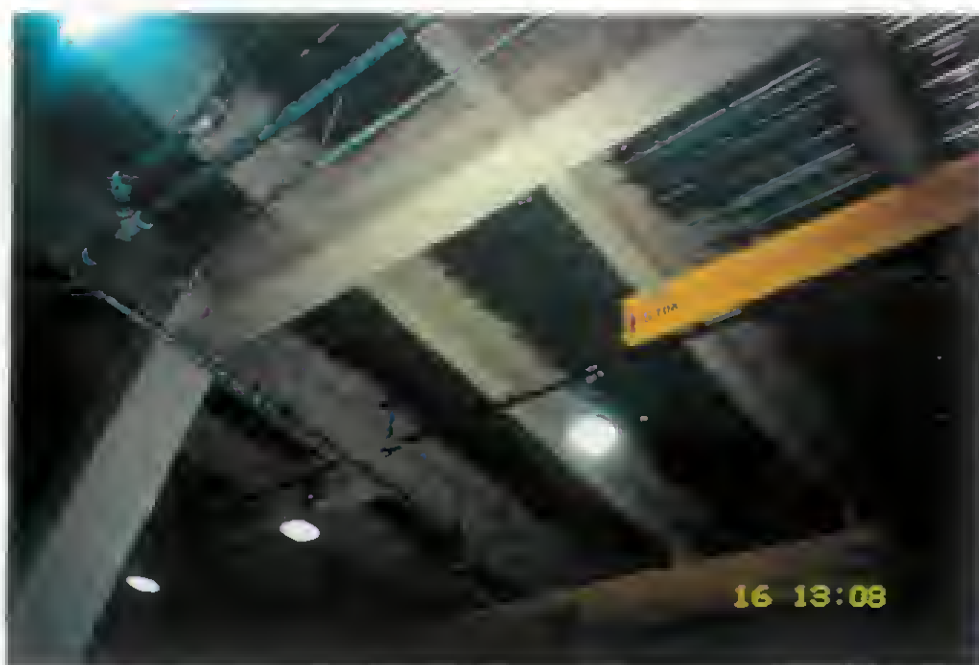
Photograph 18

New ceiling slab
installed above
refrigeration plant
due to bomb blast

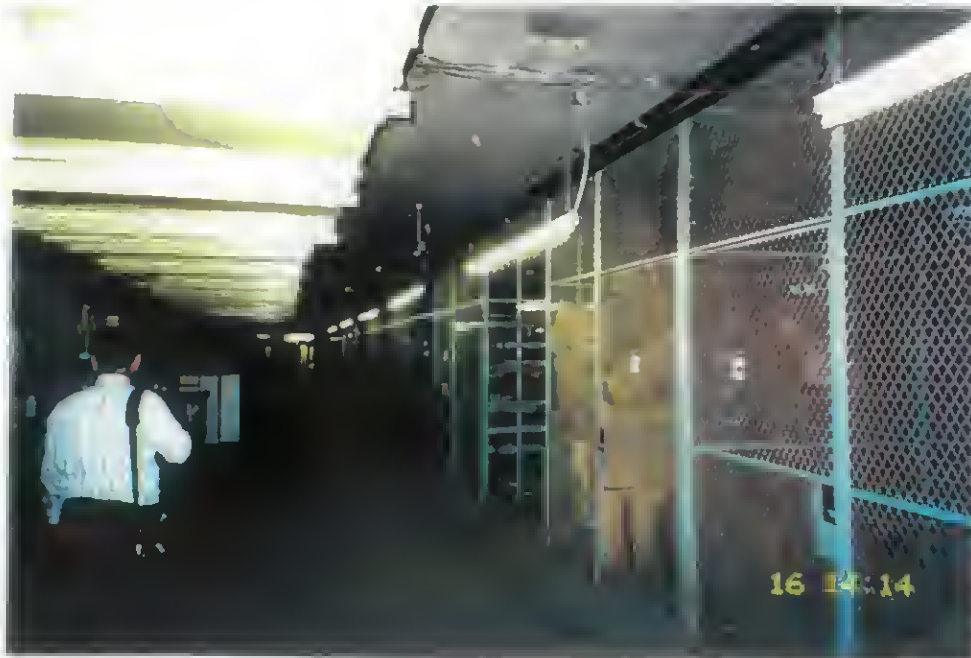
Photograph 23

**B5 and B6 storage
spaces**

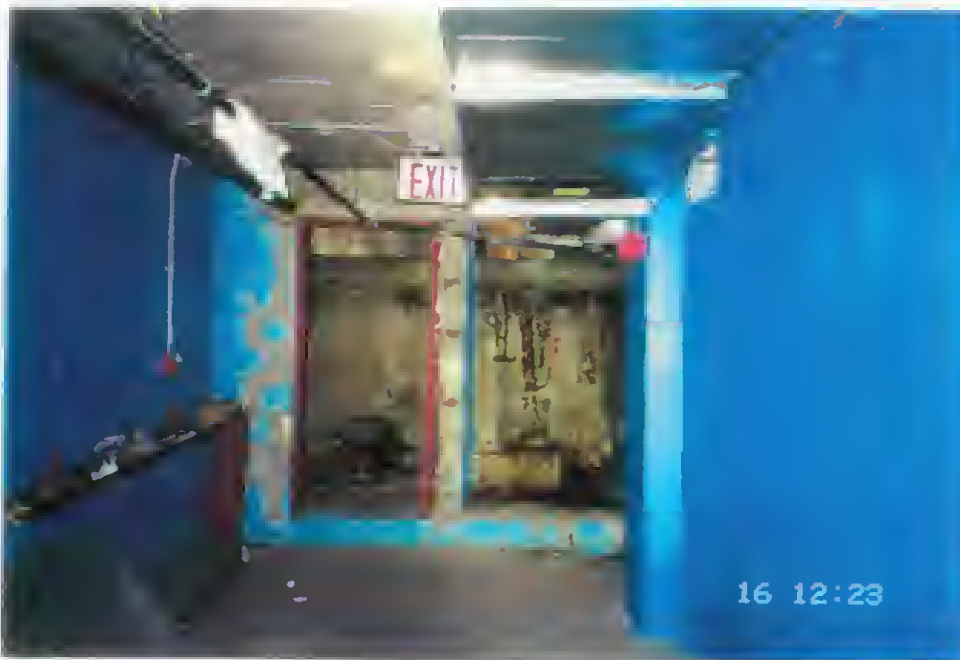
Photograph 24

**B4 northeast stair
door being replaced**

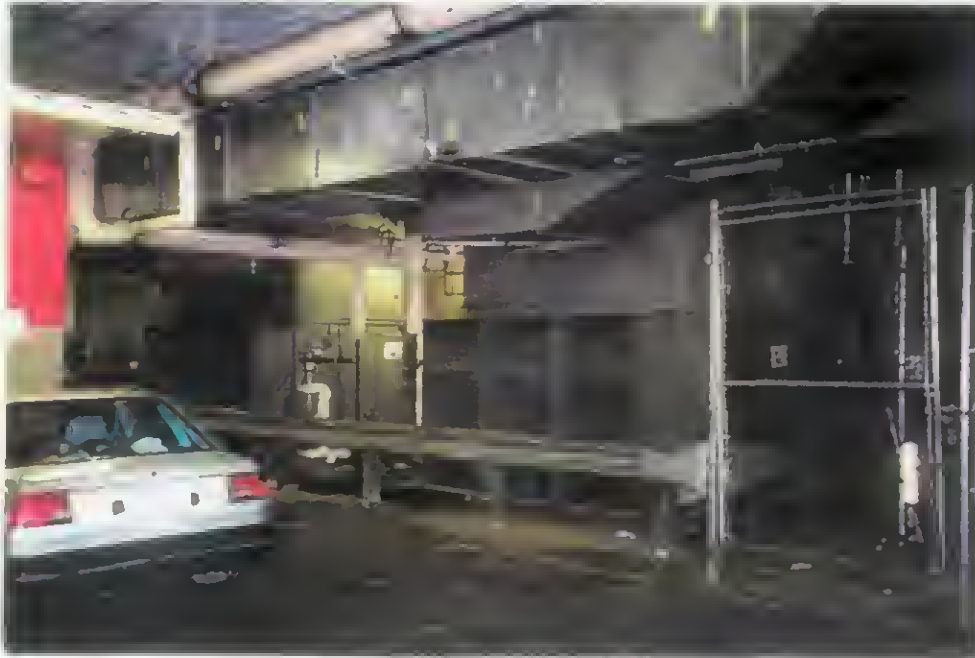
Photograph M1

Heating and
ventilating unit in the
loading dock area

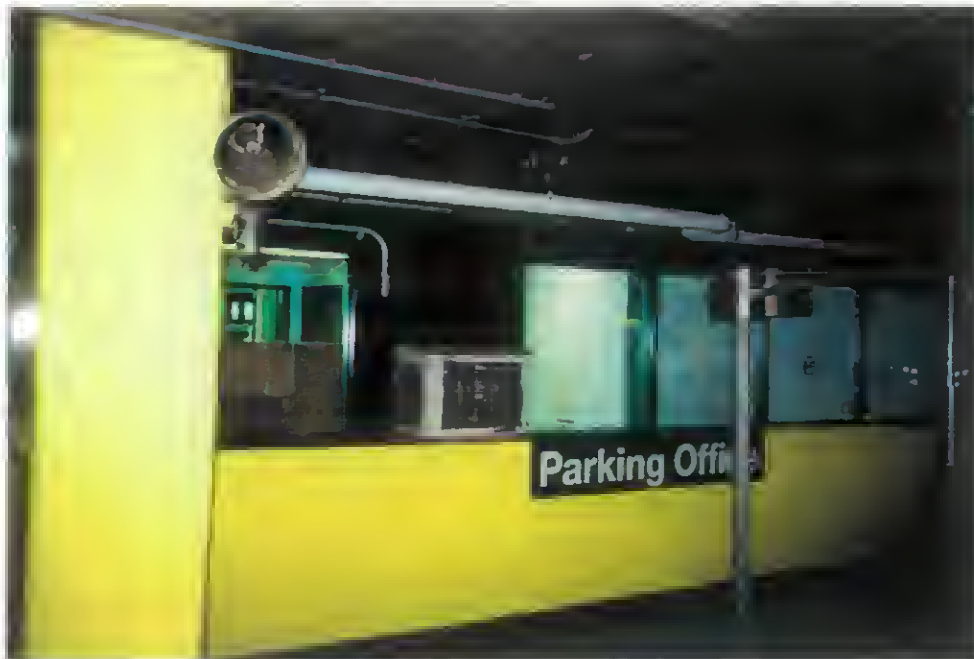
Photograph M2

Window style air
conditioning unit
used in the parking
office

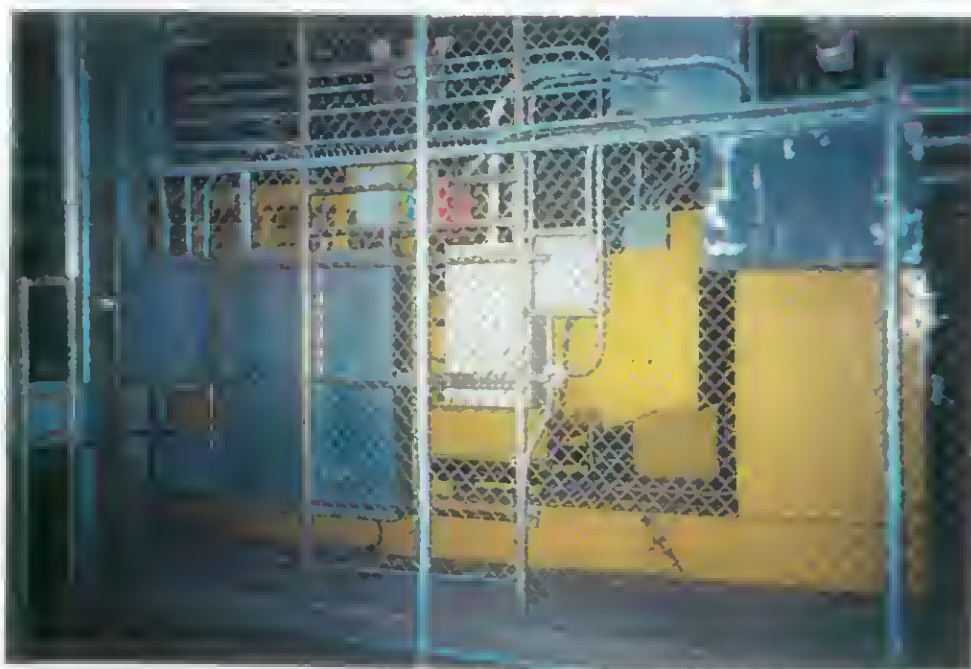
Photograph M8

**Tenant emergency
generator in the
northwest projection
area**

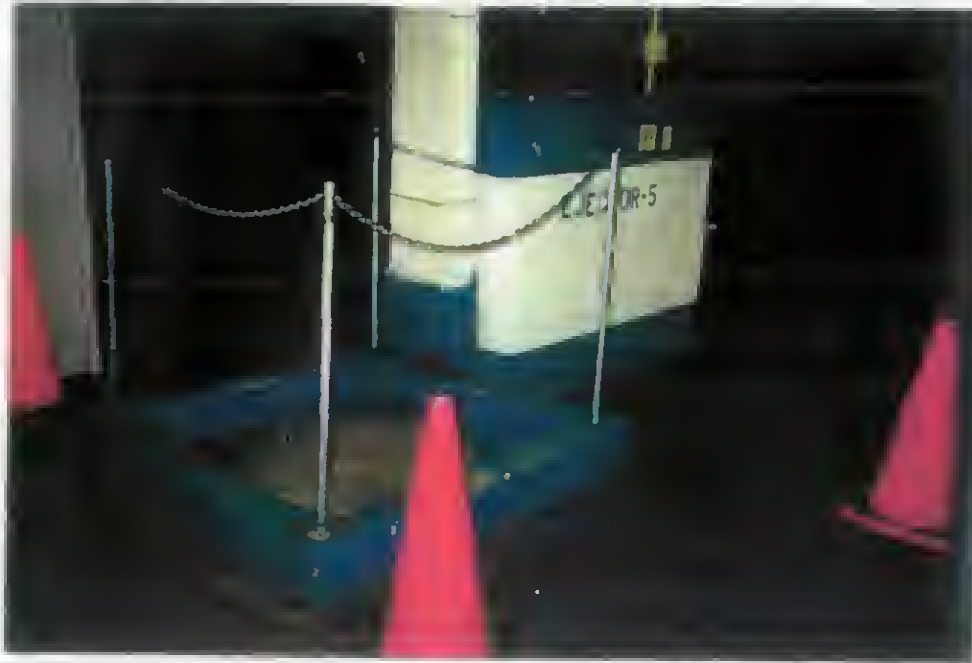
Photograph M9

Typical sewage
ejector pit

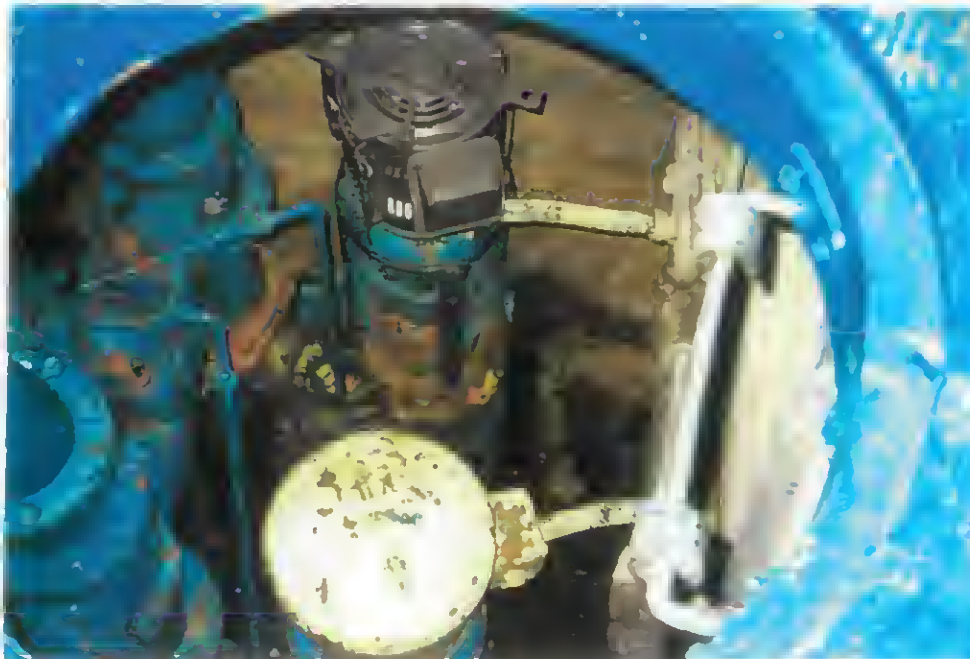
Photograph M10

Pumps within an
ejector pit

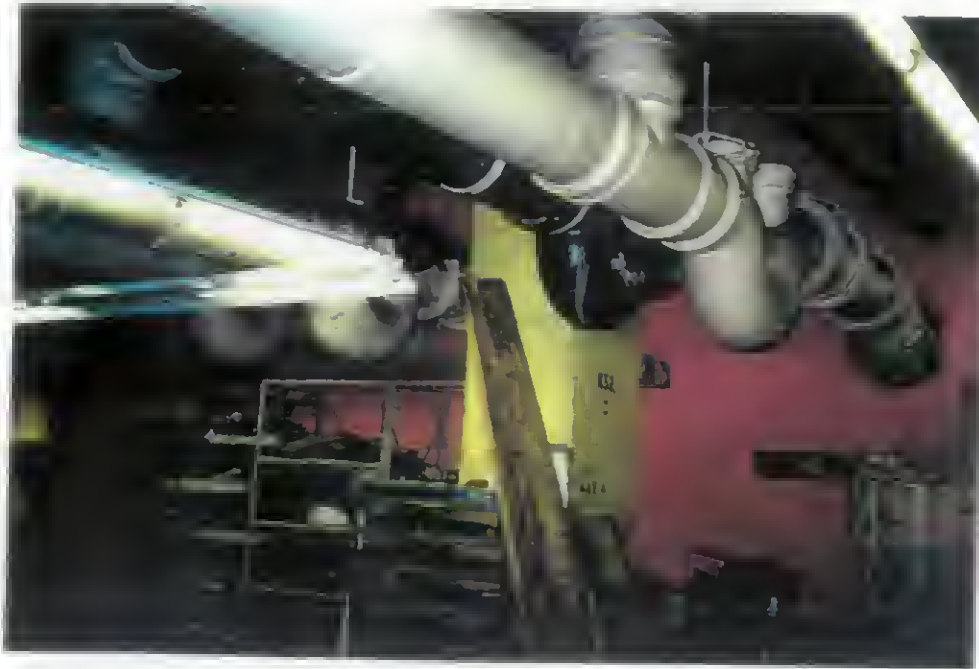
Photograph M11

House traps within
subgrade space
